Power Equipment

CODE NO: CC-188

DATE: JANUARY 19, 1990

SUBJECT: SLOW REVERSE SPEED ON 1990 HYDRO GARDEN TRACTORS

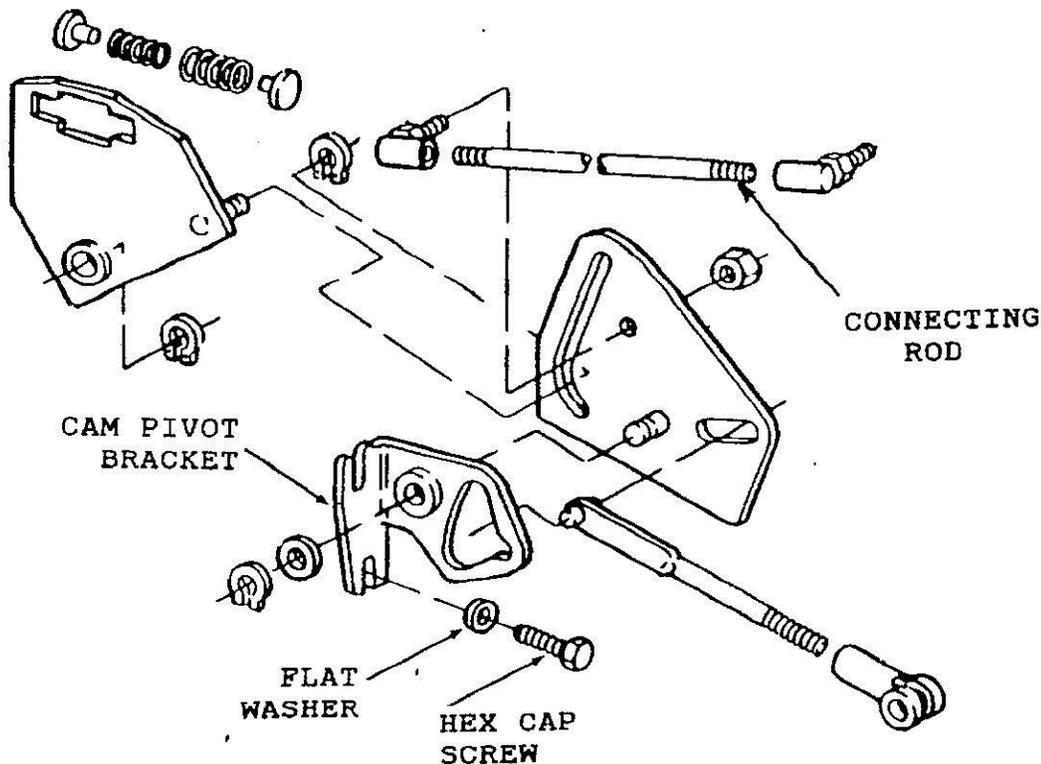
PROBLEM: CAM PIVOT BRACKET OUT OF ADJUSTMENT

SOLUTION: ADJUST CAM PIVOT BRACKET

IF YOUR REVERSE SPEED IS TOO SLOW THE CAM PIVOT BRACKET IS OUT OF ADJUSTMENT. TO CORRECT THE PROBLEM, LOOSEN THE TWO HEX CAP SCREWS SECURING THE CAM PIVOT BRACKET AND MOVE THE CAM PIVOT BRACKET DOWN UNTIL THE FLAT WASHER IS EVEN WITH THE TOP OF THE CAM PIVOT BRACKET.

TIGHTEN THE SCREWS AND TEST. IT MAY BE NECESSARY TO ADJUST THE CONNECTING ROD TO THE HYDROSTATIC CONTROL LEVER TO ALIGN THE DASHBOARD HYDROSTATIC CONTROL LEVER TO THE NEUTRAL POSITION.
