Posted on Thursday, October 6, 2005 - 12:44 am:
ok folks, here is an addition to the hydrolift pump rebuild.
SEAL REPACEMENT.

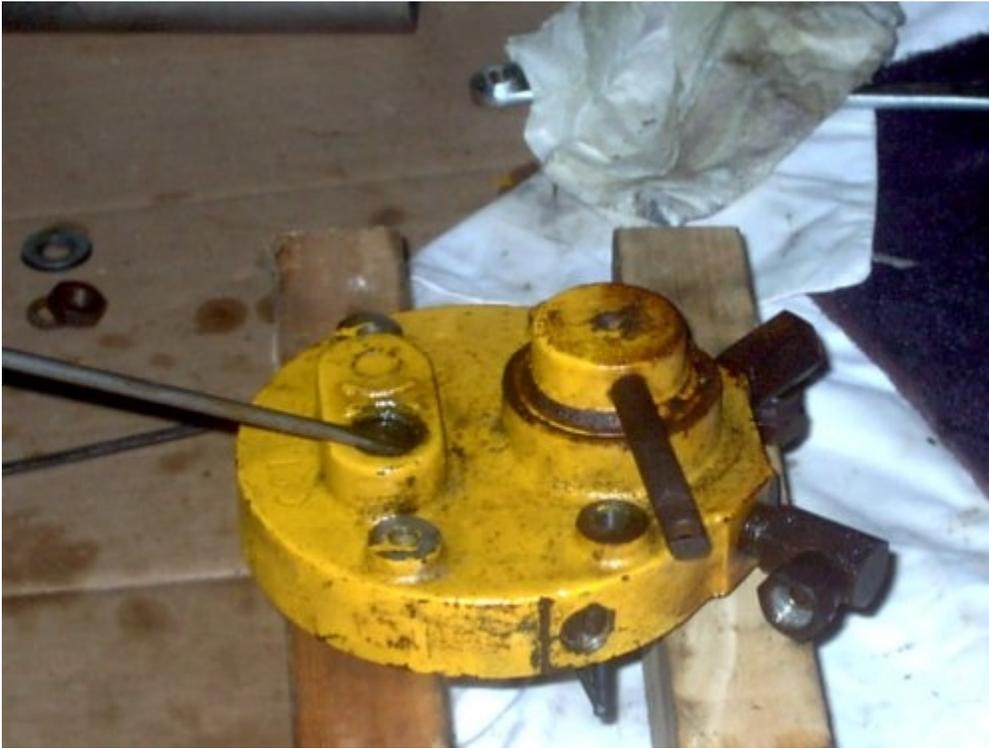
pry out old seal with screwdriver

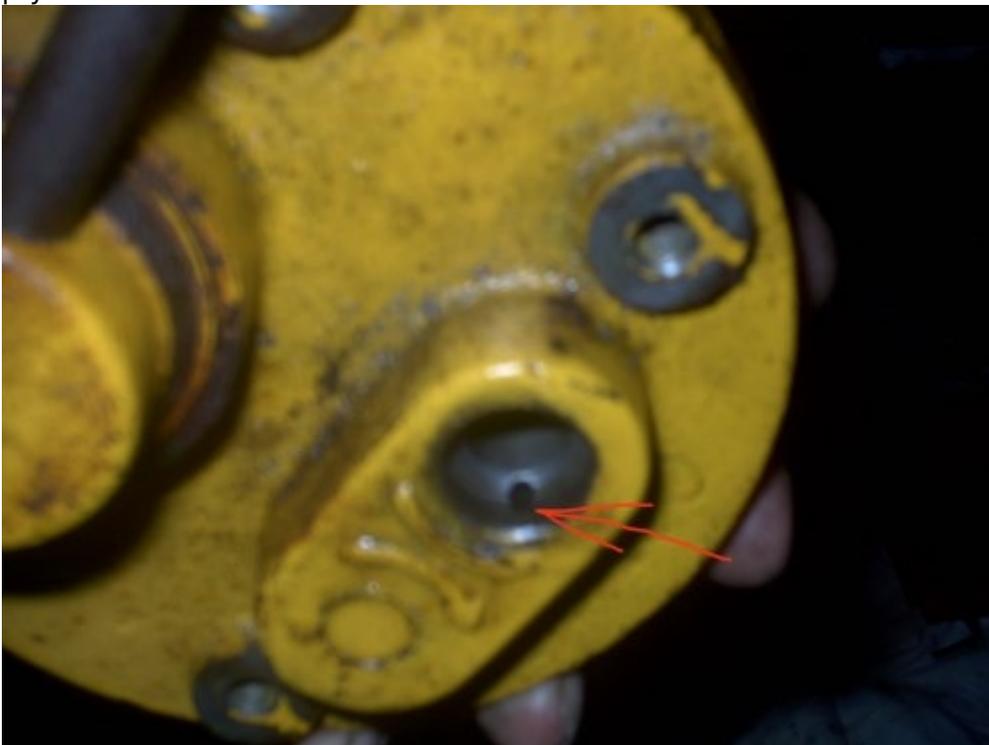
oil drain hole cannot be covered

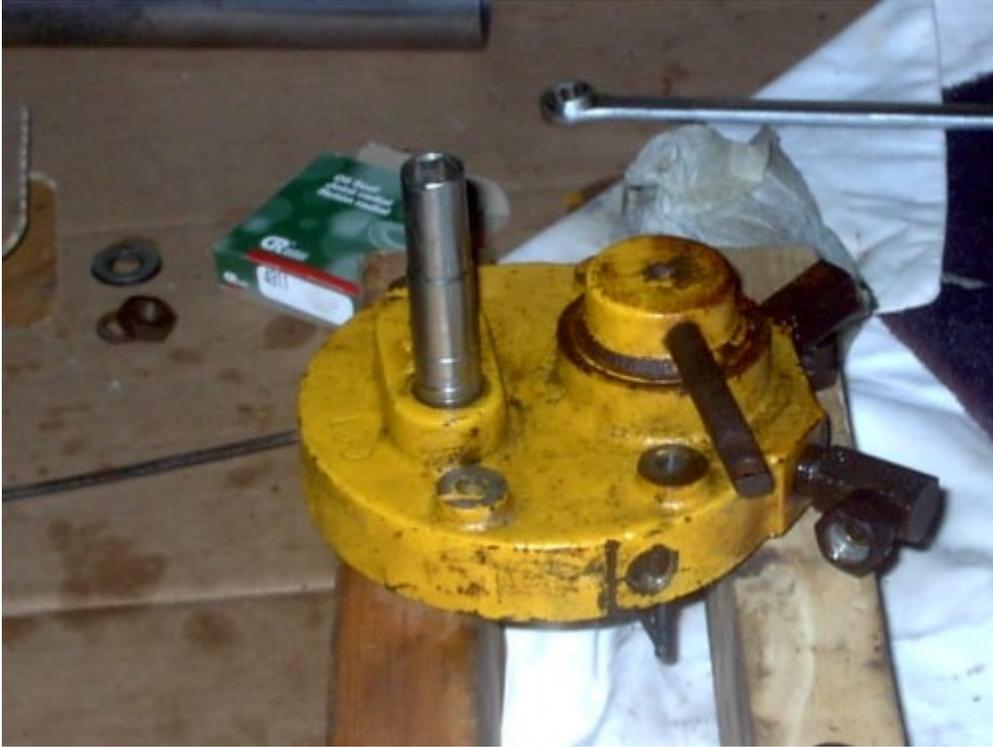
found a socket the right size to drive in first seal

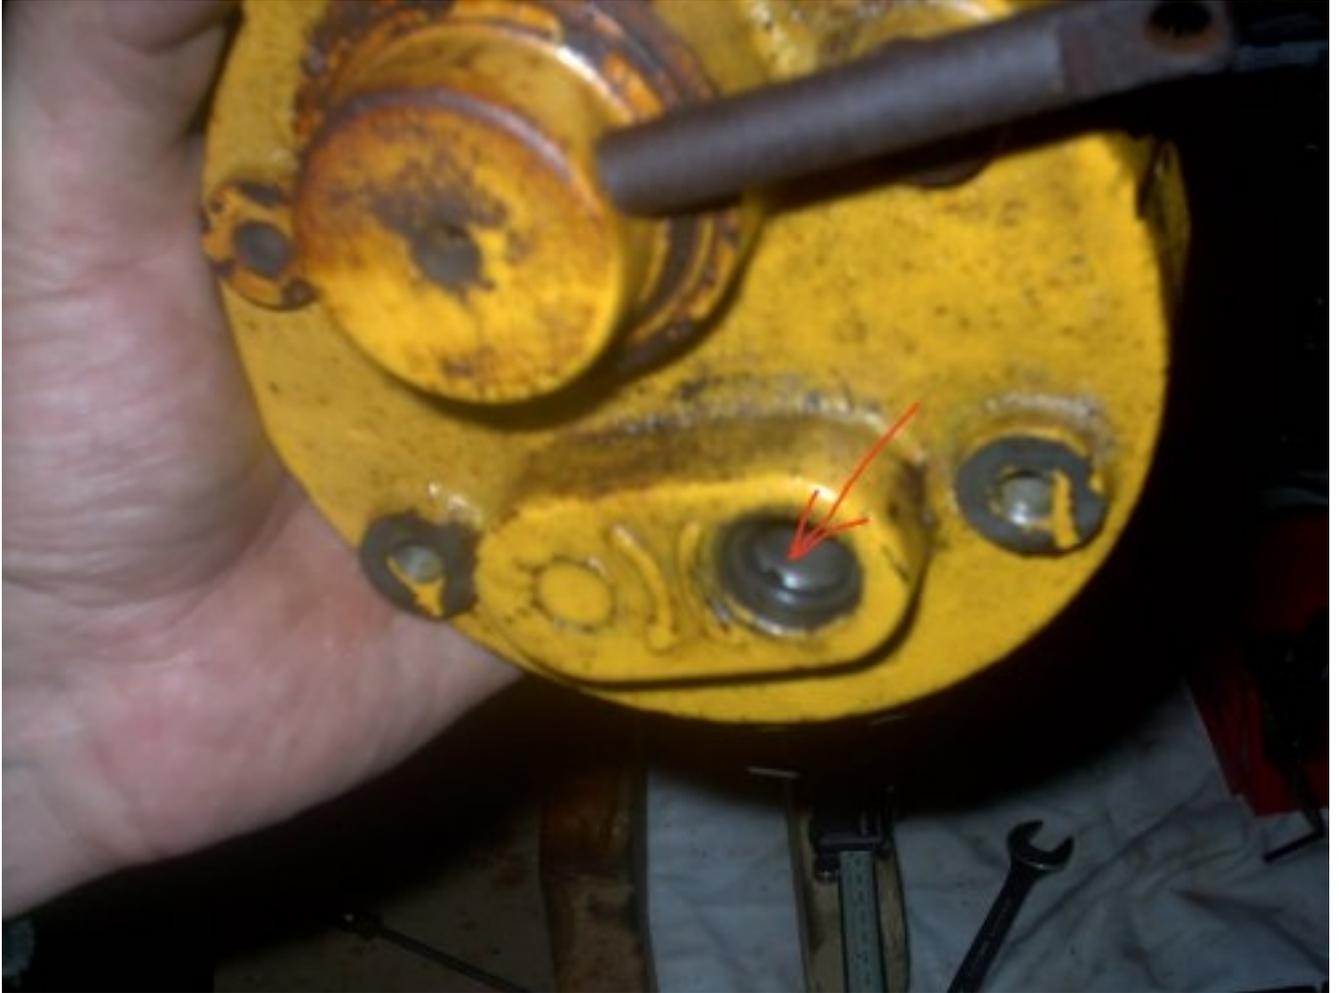
first seal installed showing drain hole still open

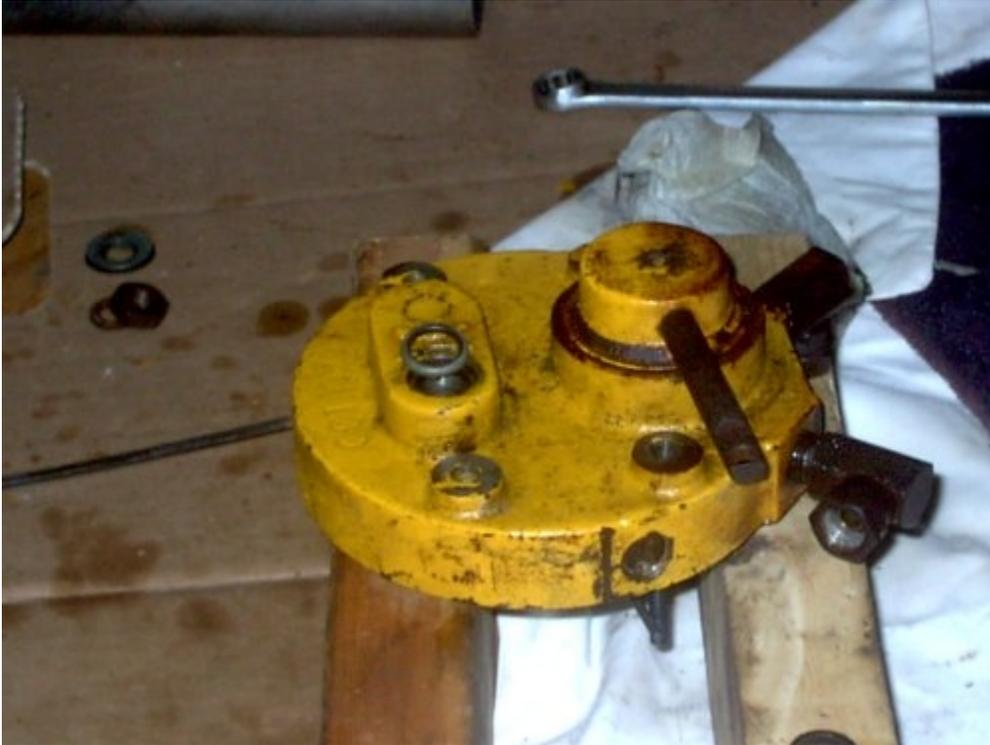
second seal goes in next, slightly below surface of casting, hole is chamfered

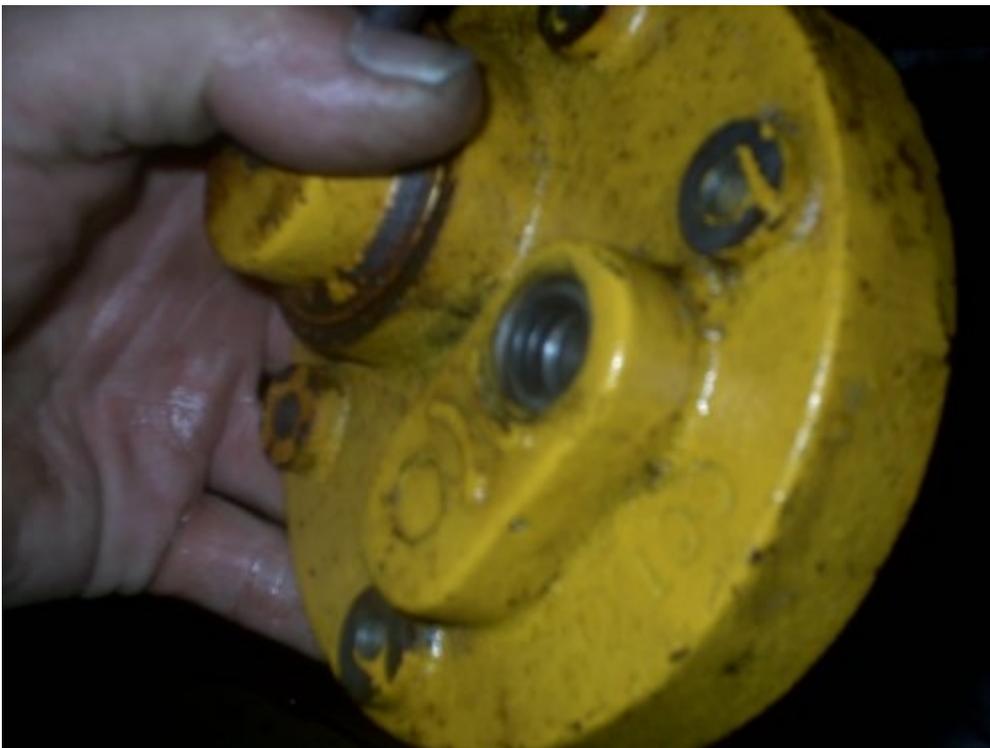
both seals in and drain hole still showing, but not in this picture! slight space between the seals to let individual seal lips move independantly

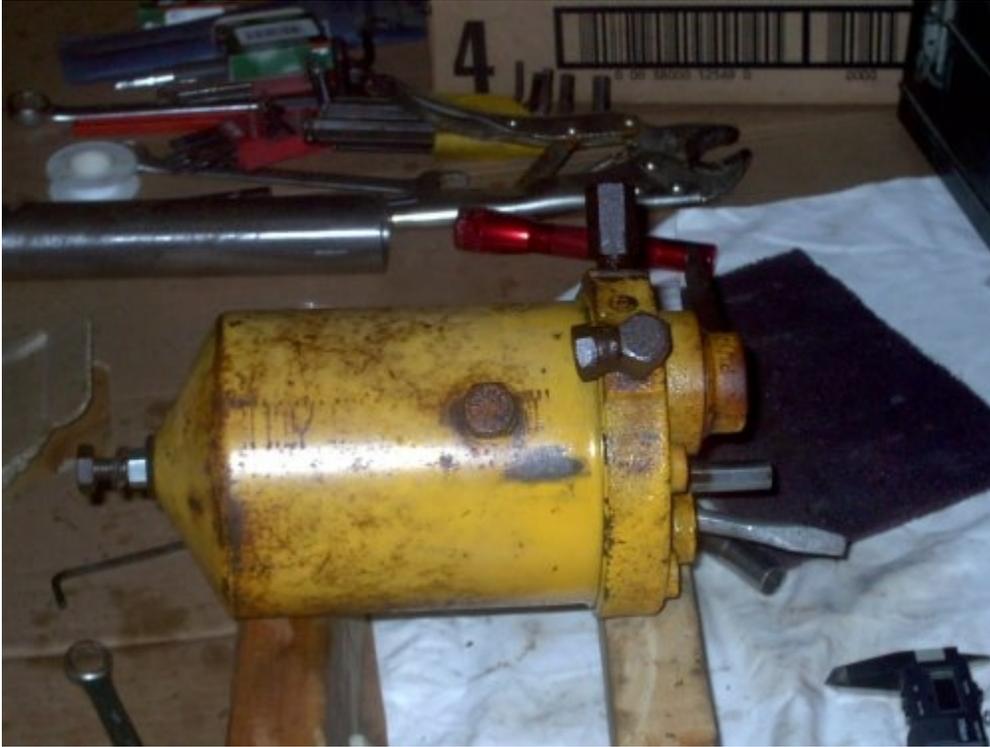
the pump ready for installation on the mounting bracket.
this concludes the hydrolift pump rebuild.
eric
